**Jamestown Parks and Recreation
Two Rivers Activity Center
Jamestown, North Dakota**

Project No. 11-073

Subject: Field Observation Report

Date: May 31, 2017

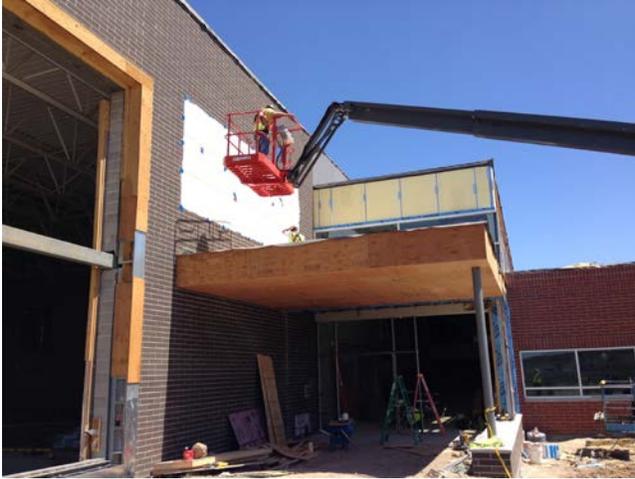
1. Main Entry: Building sign & doors are being installed.

House of Glass is working on the glass entry systems at the entry doors. Today, they are working on the main entry.

Roughrider Signs is on site today installing the "TRAC" sign above the main entrance.

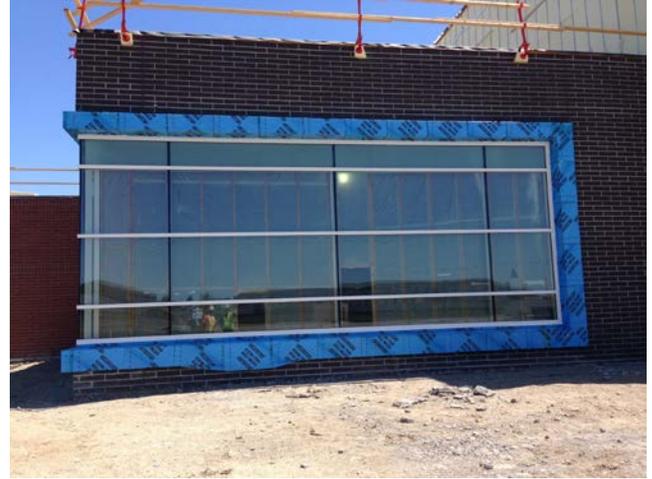
2. Lesson Pool: Window surround is ready for metal panels.

Minnkota Architectural Products is currently installing panels on the south side of the building.

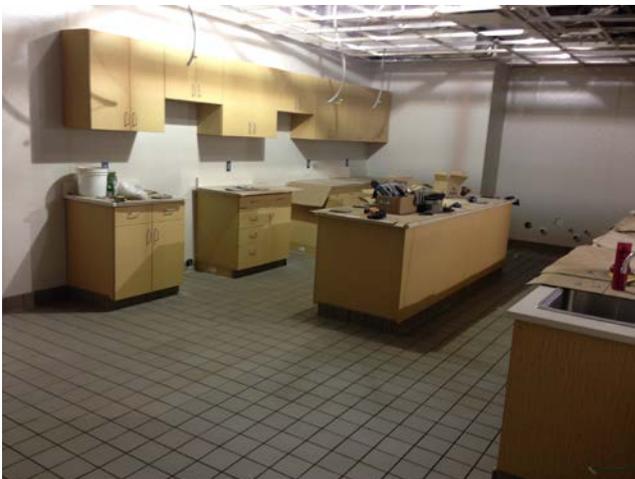
3. Kitchen: Floor tile nearly complete – waiting for grout.

Central Floor Specialties (CFS) is working on the floor tile in the kitchen. They are also prepping the childcare area for carpet and vinyl tile for next week. CFS will have the tile work in the building complete this week.

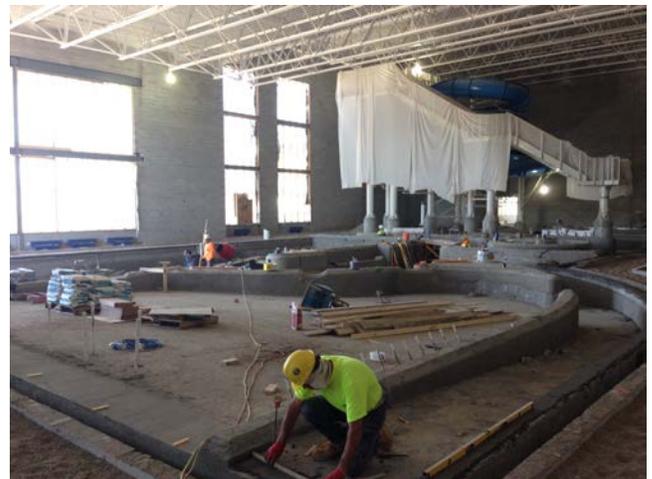
4. Rec. Pool: Phase II of pool is poured.

Associated Pool Builders has completed the pool pours for Phase II. They are currently working in the pool equipment room while their tile layers are working in the pool room. We discussed during the meeting that the saw cuts in the pool deck need to be better coordinated with the tile depth markers on the pool deck to avoid saw cuts ending at the tile. Ending a saw cuts on a tile could lead to the tile cracking.

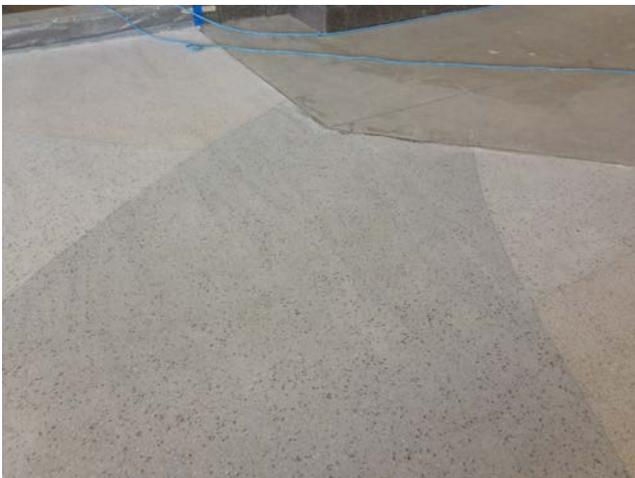
5. Main Lobby: Terrazzo floor is poured.

Advanced Terrazzo has poured all the terrazzo flooring in the main lobby. They are currently grinding the terrazzo.

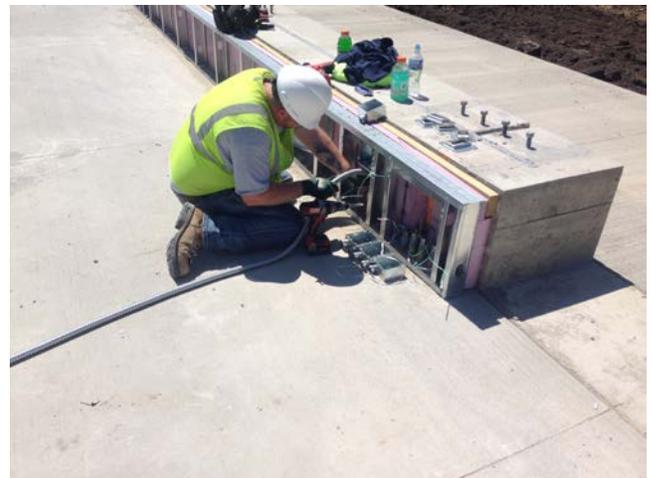
6. Air Structure: Electricians are prepping for fabric install.

Arizon will be on site next week to begin installing the air structure. They plan this to take about a week to get set up.

Magnum Electric is currently working on underground power to the parking lot light poles. They are also working on the lights throughout miscellaneous rooms and in the gymnasium. Magnum has begun pulling wire to the air structure too.
